# Manhole Inspection Summary

Manhole # S39A2\_014MH

Insp Date: **4/9/08 11:23 AM**

**Location** Address: **E. Tablot St. (Near the School)**

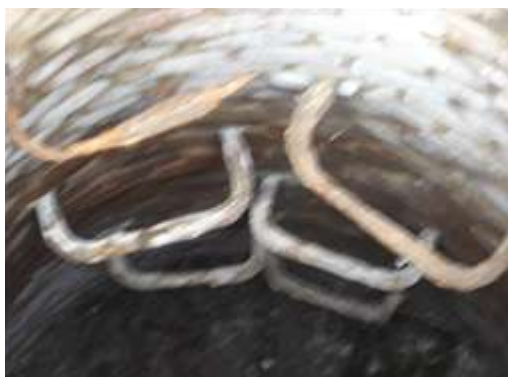
Steps

Count: **5** Missing: **1** ☒ **Corroded**

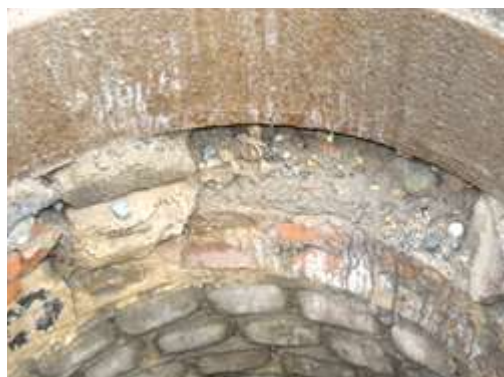
Defect 1

Condition: ☐ Sound ☐ Cracked ☐ Root Intrusion ☐ Loose Brick ☒ **Deteriorated**

Infiltration: ☐ None ☒ **Joint** ☐ Cracks ☐ Mortar ☐ Roots ☐ Wall

Deteriorated Chimney/Frame Adjustment

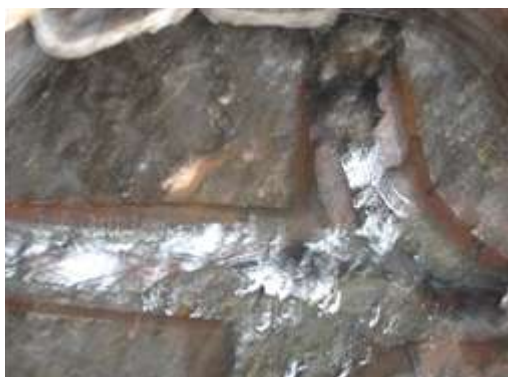
Defect 2

Condition: ☐ Sound ☐ Cracked ☐ Root Intrusion ☐ Deteriorated ☐ Leaks ☒ **Debris**

Debris on bench and Channel

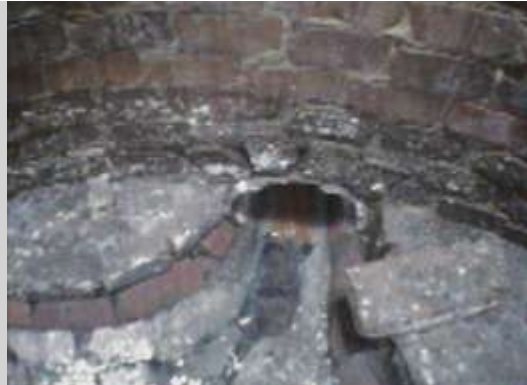
12 O'Clock Outflow

8 in. Circular Gravity Sewer  
Pipe Out @ 12 O'Clock

Pipe Height: **8.4** (in.) Rod and Bar (Angled)  
Pipe Material: **Clay** ☐ Pipe Lined  
Invert Depth: **12.18** (ft.) Flow Characteristics: **Fast**  
Deposits: ☒ None ☐ Mud ☐ Sludge ☐ Debris ☐ Grease  
Silt Depth: (in.) Deposits Extent:  
Infiltration: **None** Pipe Seal Cond: **Unknown**

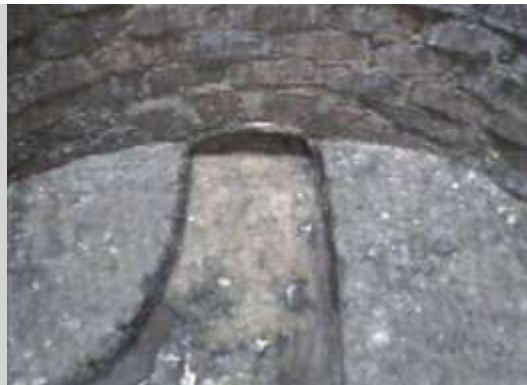
3 O'Clock Inflow

8 in. Circular Service Sewer  
Pipe In @ 3 O'Clock

Pipe Height: **8.4** (in.) Rod and Bar (Angled)  
Pipe Material: **Clay** ☐ Pipe Lined  
Invert Depth: **11.86** (ft.) Flow Characteristics: **None**  
Deposits: ☐ None ☐ Mud ☒ **Sludge** ☐ Debris ☐ Grease  
Silt Depth: **5** (in.) Deposits Extent: **Medium**  
Infiltration: **None** Pipe Seal Cond: **Unknown**

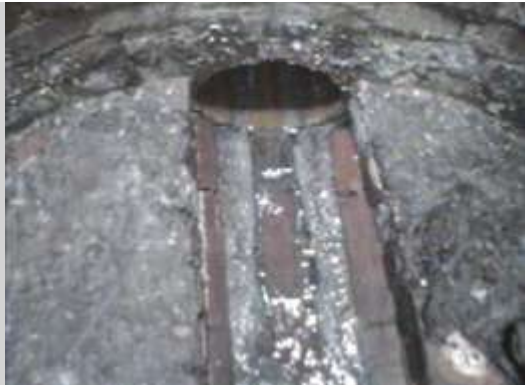
6 O'Clock Inflow

8 in. Circular Gravity Sewer

Pipe In @ 6 O'Clock

Infiltration: **None** Pipe Seal Cond: **Sound**

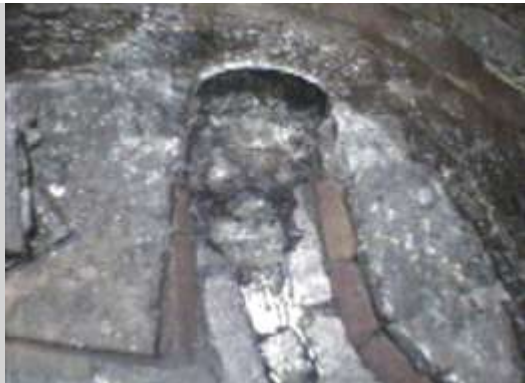
9 O'Clock Inflow

4 in. Circular Gravity Sewer

Deposits: ☐ None ☐ Mud ☐ Sludge ☒ **Debris** ☐ Grease

Silt Depth: **4** (in.) Deposits Extent: **Heavy**
